# Manhole Inspection Summary

Manhole # S37II\_005MH

Insp Date: **3/15/07 12:36 PM**

**Location** Address: **425 FEDERAL ST**

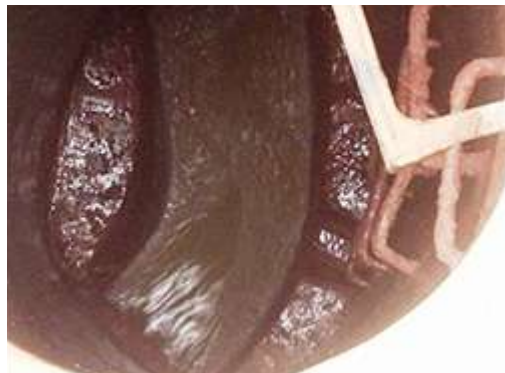
Top View

Corroded steps. Bench debris.

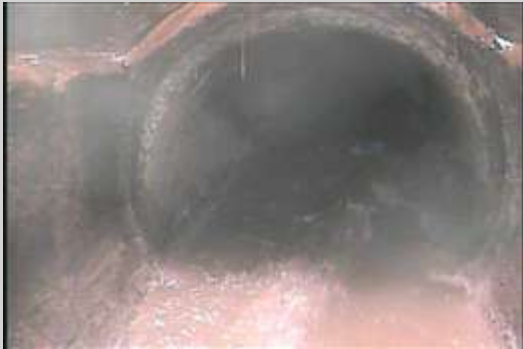
### 18 in. Circular Gravity Sewer Pipe Out @ 12 O'Clock

Pipe Material: **PVC** ☐ Pipe Lined

Invert Depth: **17.55** (ft.) Flow Characteristics: **Fast**

Infiltration: **None** Pipe Seal Cond: **Unknown**

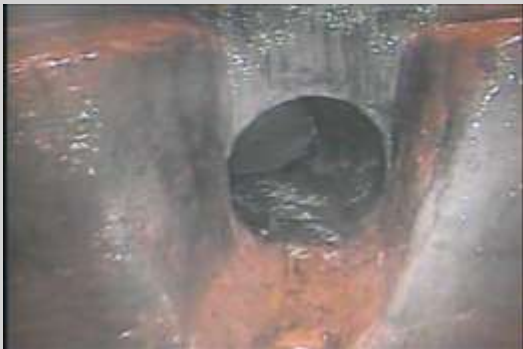
### Pipe In @ 4 O'Clock

Connects To: **Stub connection / abandoned**

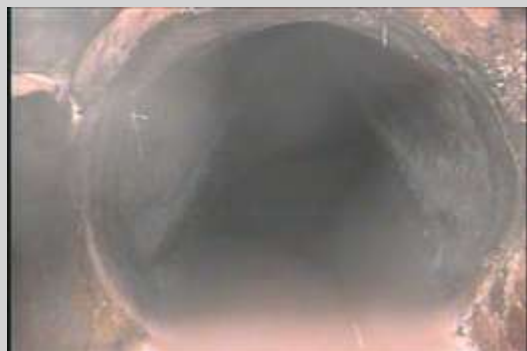
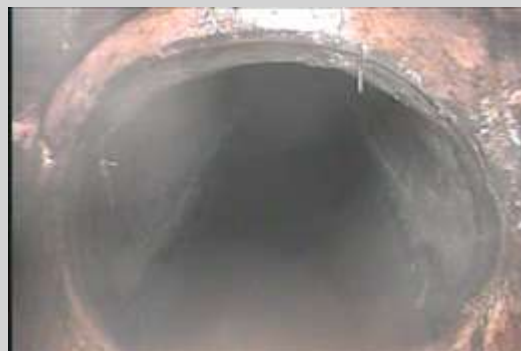
Pipe In @ 8 O'Clock

Pipe Material: **Clay**

Invert Depth: **17.30** (ft.) Flow Characteristics: **Fast**

Infiltration: **None**
